Diopter Pins Broke? Work It Won't!

OK, let's focus on the problem with AN/PVS-7B and AN/PVS-7D night vision goggles. The problem at hand is focus! Or, rather, a lack of focus due to busted diopter adjustment ring pins.

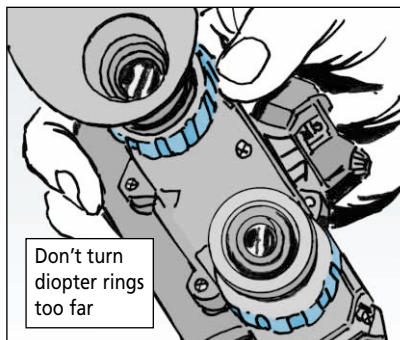
The ring adjusts for the sharpest image possible in a range of +2 to -6 diopters. This represents about half a turn of the ring.

But some of you want more. You keep adjusting when there is no place to adjust to! It's not long until the pins in the ring that define the stopping points are busted. Then it's impossible to hold focus.

So here's the rule: When the ring stops turning, stop turning it!
